Comparison of FEE vs. SEE

Lee Andrews, PE, SE

January 24, 2020

10 Bridges

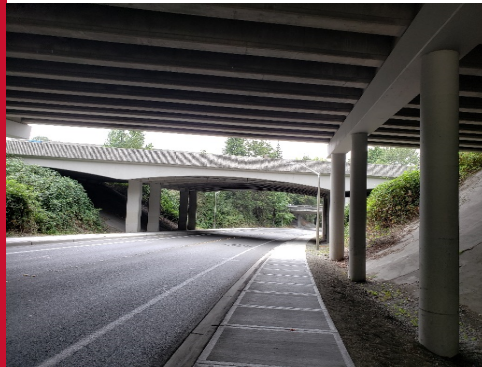
Bridge 405/47W

PIER 3 – Original (SEE)				PIER 3 – Widening (SEE)				PIER 3 – Original (FEE)				PIER 3 – Widening (FEE)			
PILE CAP	C/D	Dem	Cap	PILE CAP	C/D	Dem	Cap	PILE CAP	C/D	Dem	Cap	PILE CAP	C/D	Dem	Cap
Cap M (k-ft)	-	898	-	Cap M (k-ft)	0.79	1712	1352	Cap M (k-ft)	-	1380	-	Cap M (k-ft)	2.00	2777	5562
Cap V (k)	0.52	828	434	Cap V (k)	0.80	1160	930	Cap V (k)	0.74	589	434	Cap V (k)	1.10	825	906
Pile Axial (k)	0.72	185	134	Pile Axial (k)	0.72	197	142	Pile Axial (k)	1.07	125	134	Pile Axial (k)	0.90	158	142
Pile Shear (k)	2.58	13	34	Pile Shear (k)	1.87	22	41	Pile Shear (k)	5.35	6	34	Pile Shear (k)	3.30	12	41
Pile Pull Out (k)	0.03	98	2	Pile Pull Out (k)	0.03	86	2	Pile Pull Out (k)	0.06	38	2	Pile Pull Out (k)	0.07	30	2
COLUMN				COLUMN											
Long. Disp. (in)	0.89	14.0	12.5	Long. Disp. (in)	2.36	11.4	27.0								
Transv. Disp (in)	1.13	6.0	6.8	Transv. Disp (in)	2.51	6.0	15.0								
Shear (k)	0.84	196	165	Shear (k)	1.66	427	708

CROSSBEAM				CROSSBEAM											
Moment (k-ft)	0.49	1686	821	Moment (k-ft)	0.51	1616	821								
Shear (k)	0.51	426	217	Shear (k)	0.90	487	437

The results were similar between all three bridges, though the foundations for bridge 47W did have better C/D ratios.
